**Lummi Nation Wetland and Habitat Mitigation Bank
2014 (Year 1) Monitoring Report for 2013 Enhancement Areas
Phase 1A Nooksack Delta Site**

October 2015

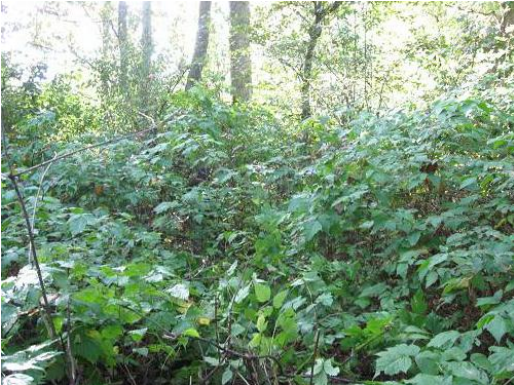
Conifer Transect Identifier	Image From Center of Station
CT040	 
CT041	 
CT042

(End of Year 1)
